SUBSURFACE INVESTIGATION

PELICAN SHORES  
NORTHWEST CORNER OF CR 13 AND CR26  
WELD COUNTY, COLORADO

MARCH 9, 2004

PROJECT 2002-89

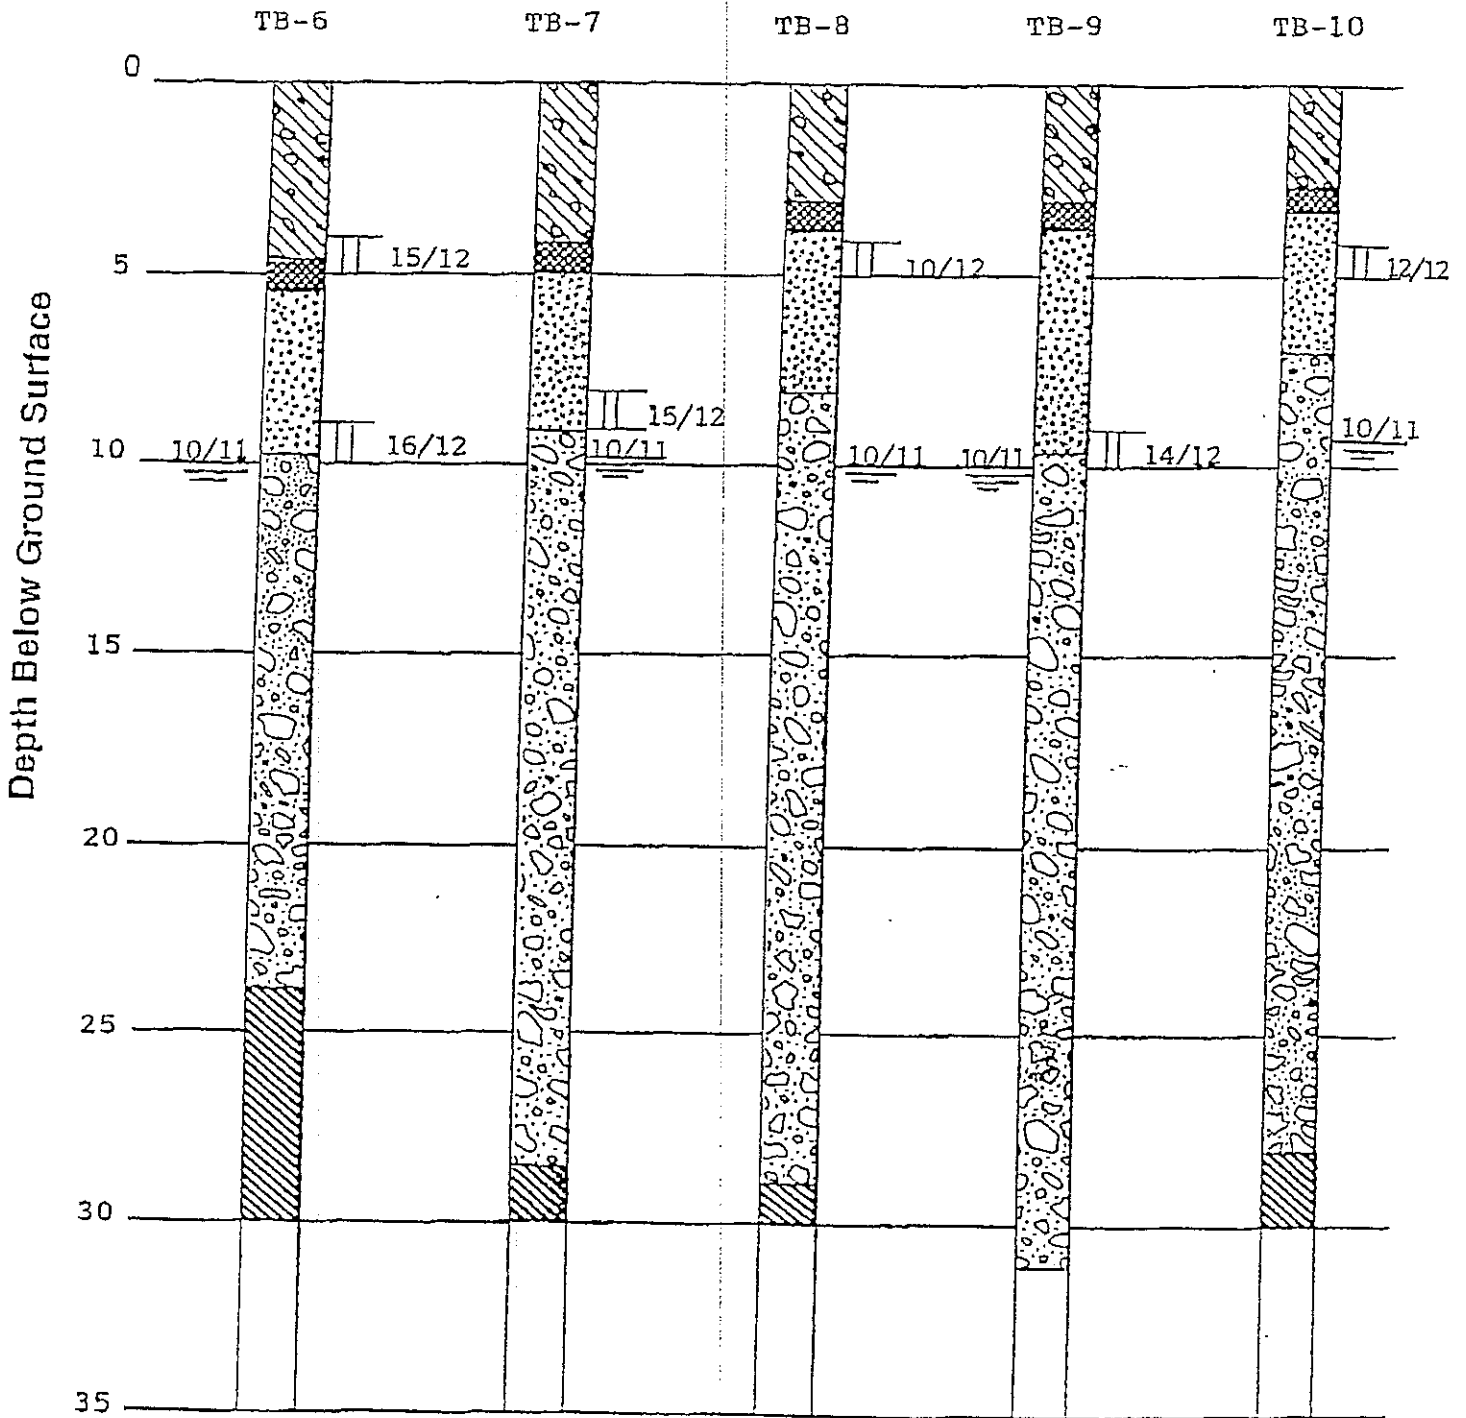
## FIGURE 3

# Boring Logs

Factual data gathered during the field and laboratory work is summarized in Figure 3 and Table 1 attached. The results of this investigation and our opinions that are based on this investigation and our experience in the general area are summarized in this report.

A more complete description of the subsurface soil conditions can be found on the Boring Logs, Figure 3.
